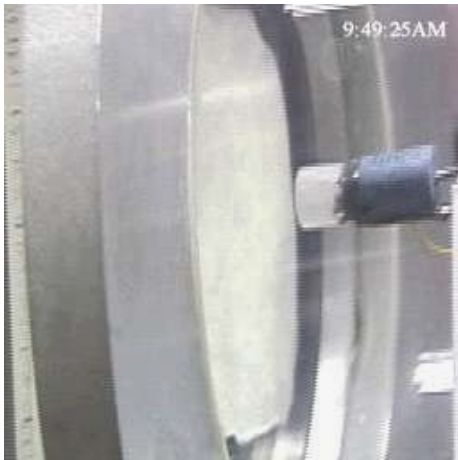
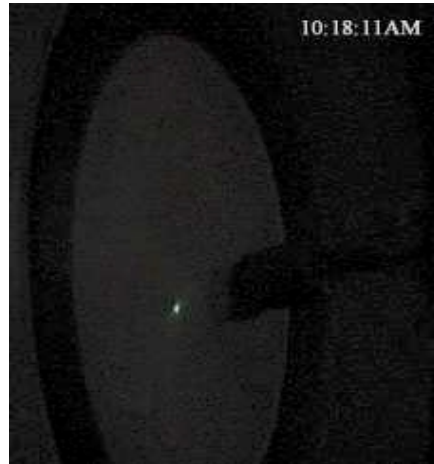
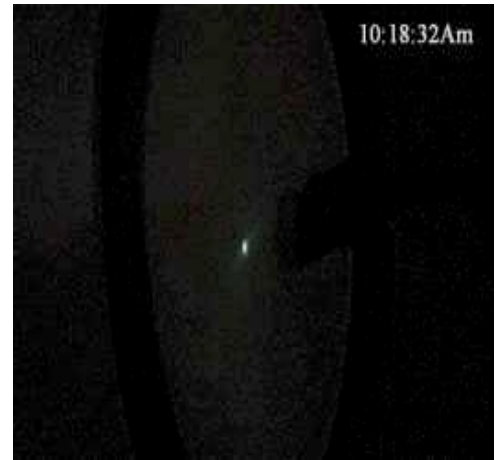
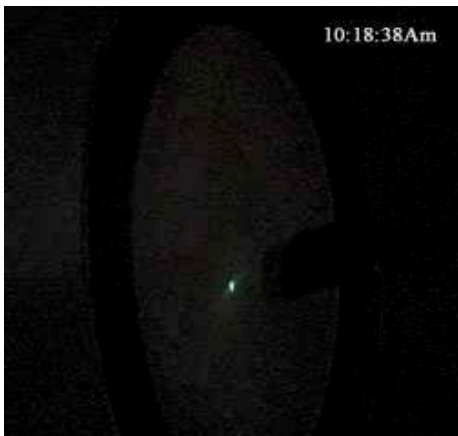
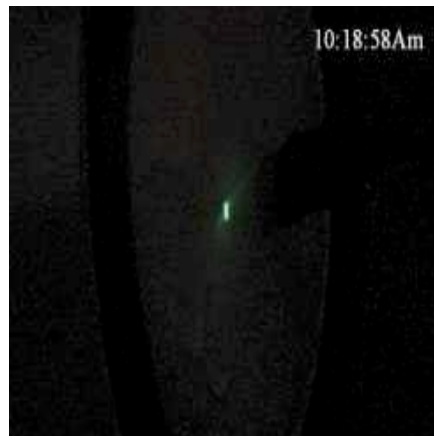
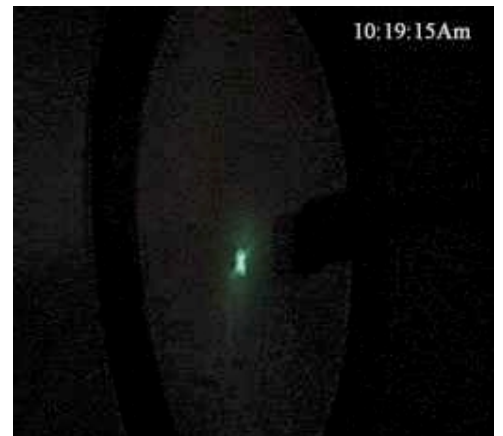
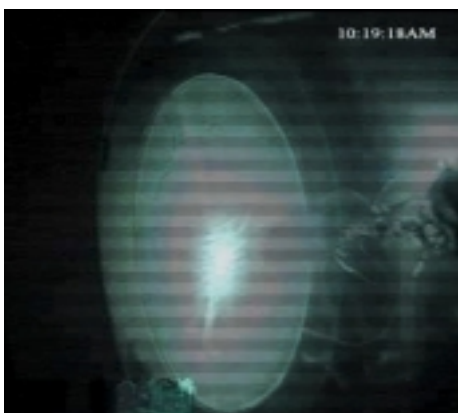
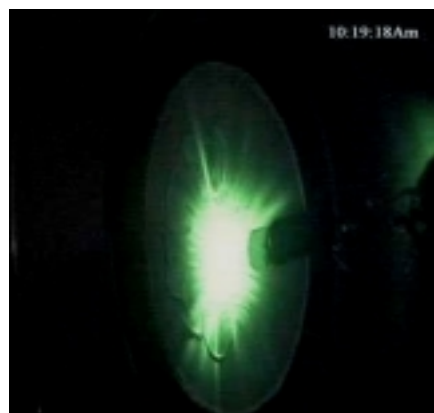
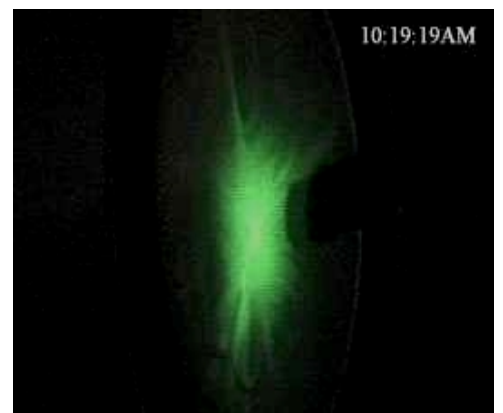
Here we show a series of photographs of the electron beam imaged on a ZnS screen. We have observed a stable beam for over 16 hours under stable pressure conditions. Here, the pressure is slowly changing from below 1 mtorr to ~8 mtorr at which time the beam blow up with a discharge of electrons into the ZnS screen.
